2016 Operations, Maintenance, and Monitoring Report

Sabine Structure Replacement

State Project Number CS-23
Priority Project List 3

February 2016
Cameron Parish

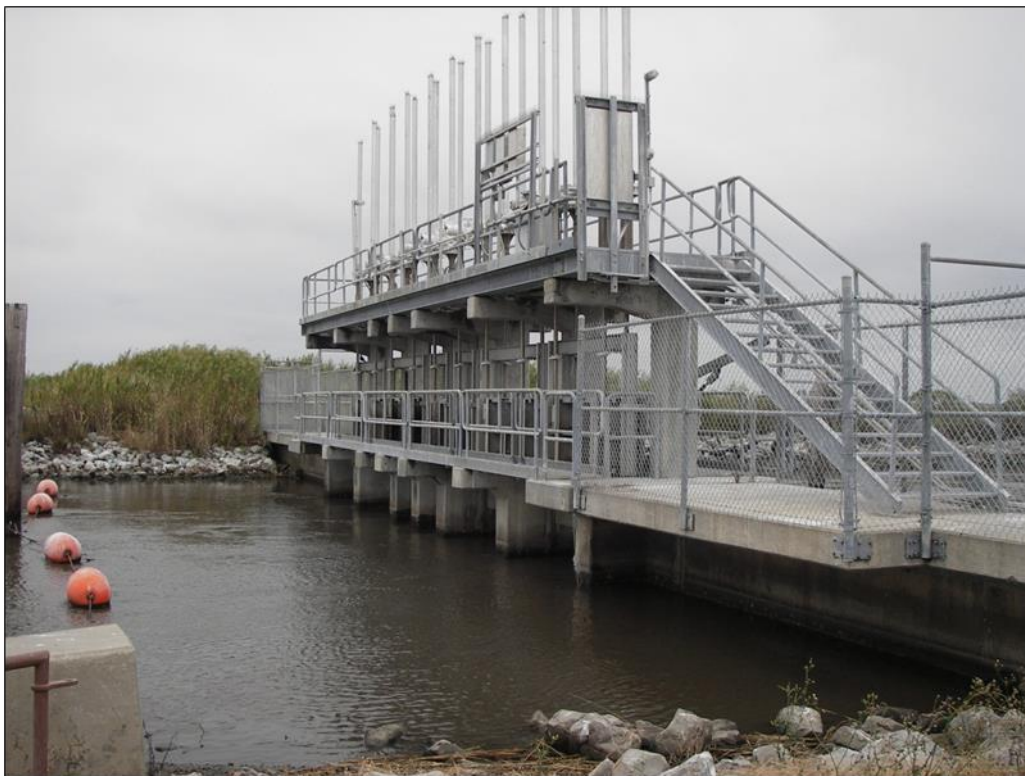
The structure is in fully operational condition as a result of the 2011 maintenance event. The conversion from single to dual stems appears to have helped with the operation of the gates. (Photos: Appendix A, Photos 1 - 2)

Photo No.1, Hog Island Gully Structure looking from the Hwy 27 side.

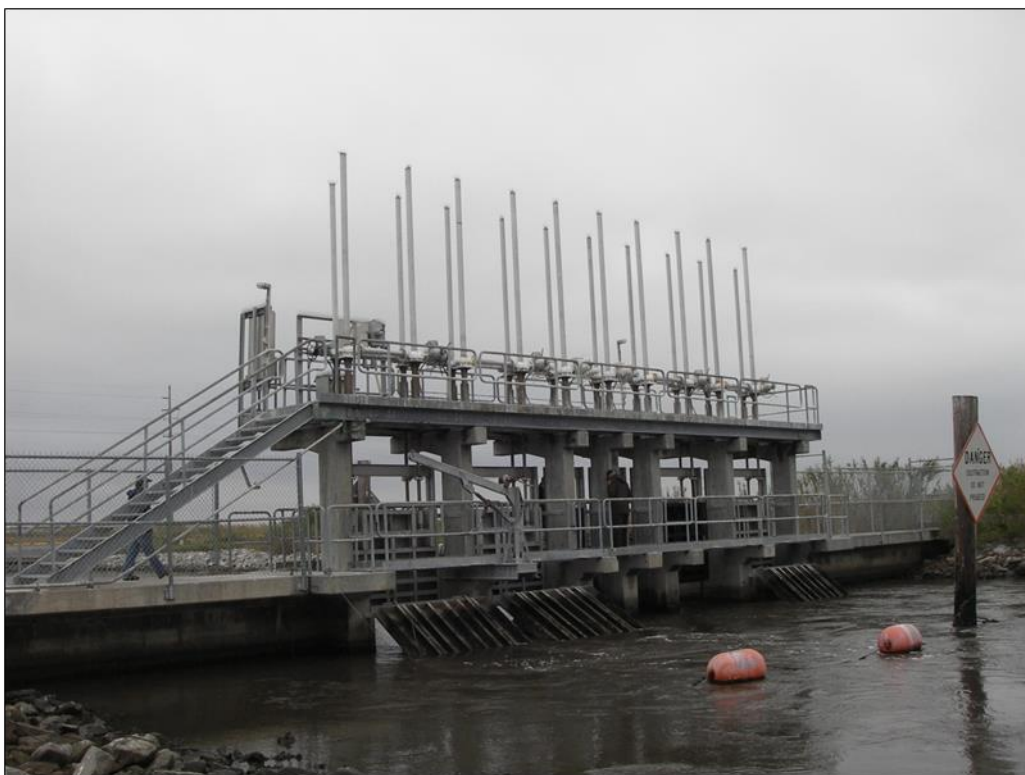
Photo No. 2, Hog Island Gully Structure from the Calcasieu Lake side– gates being exercised and in open position

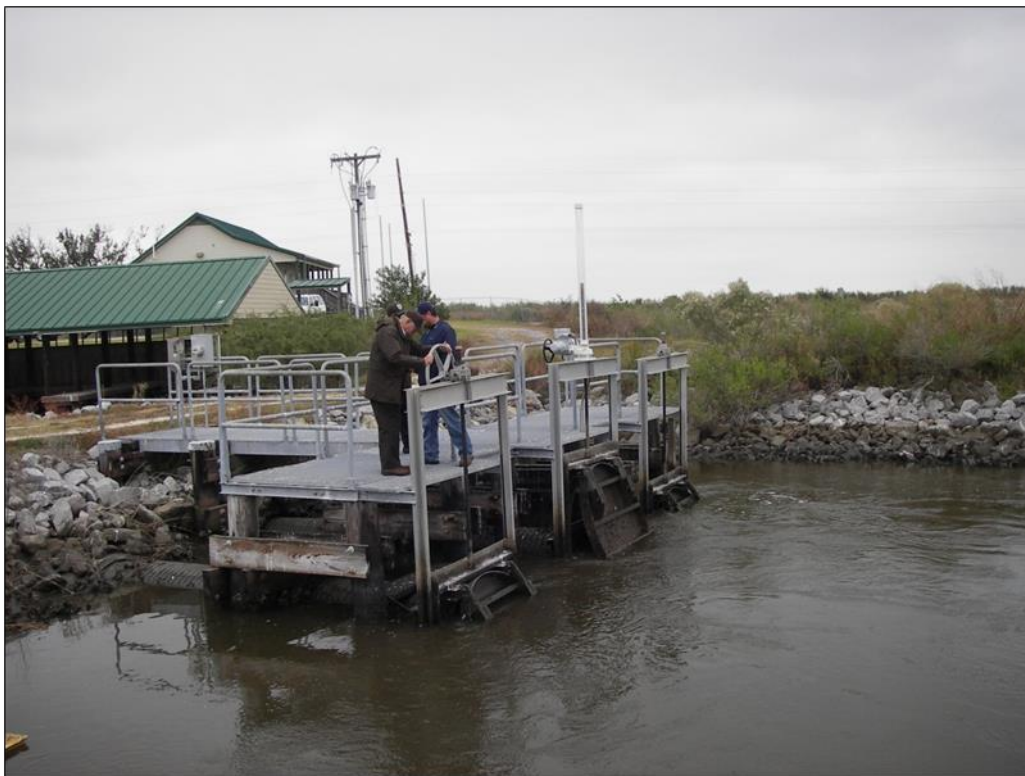
The structure is in fully operational condition, with the exception of structure No. 3 gear box repair, as a result of the 2011 maintenance event. (Photos: Appendix A, Photos 3-4).

Photo No. 3, Headquarters Structure with outside flapgates flapping

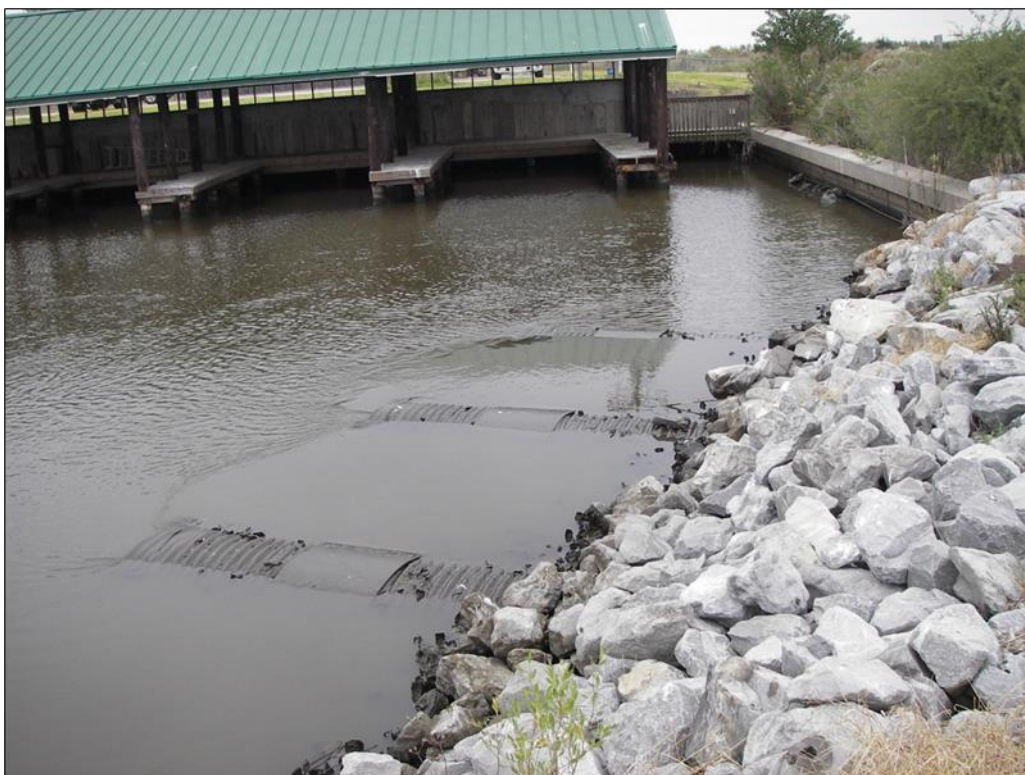
Photo No. 4, Headquarters Structure marsh side culverts with riprap

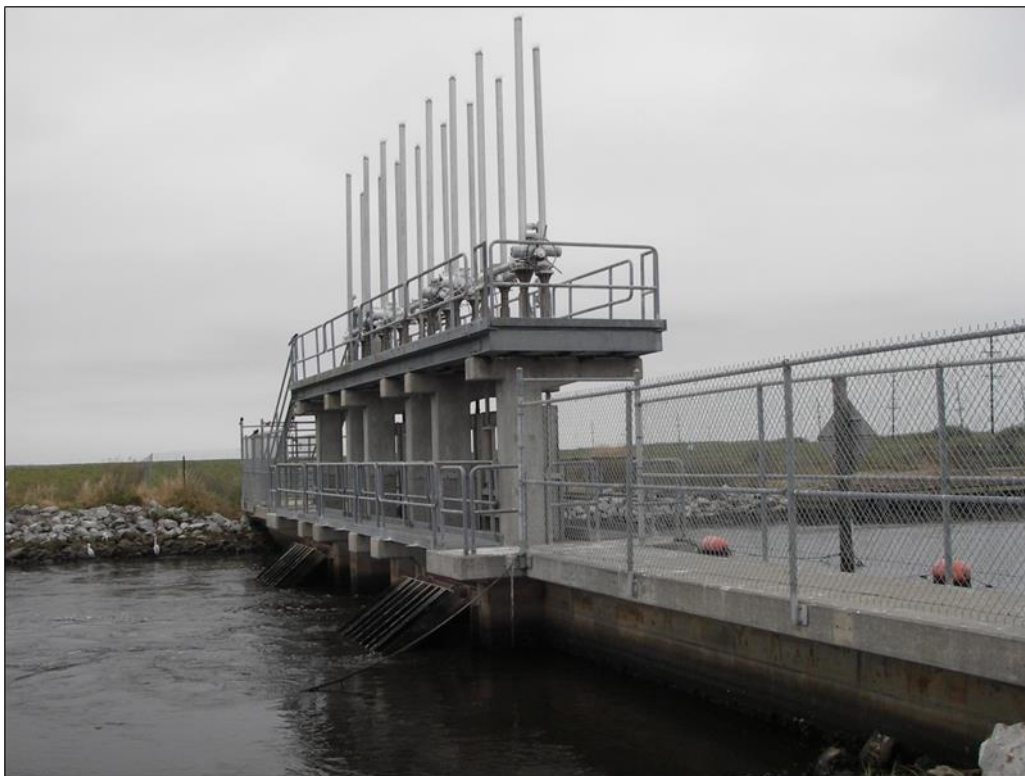
During the 2014 inspection, the structure was not operational. However, minor maintenance has been performed and the structure is fully operational at this time. The conversion from single to dual stems appears to have helped with the operation of the gates. (Photos: Appendix A, Photos 5-6).

Photo No. 5, West Cove Canal Calcasieu Lake side of structure with flapgate flapping

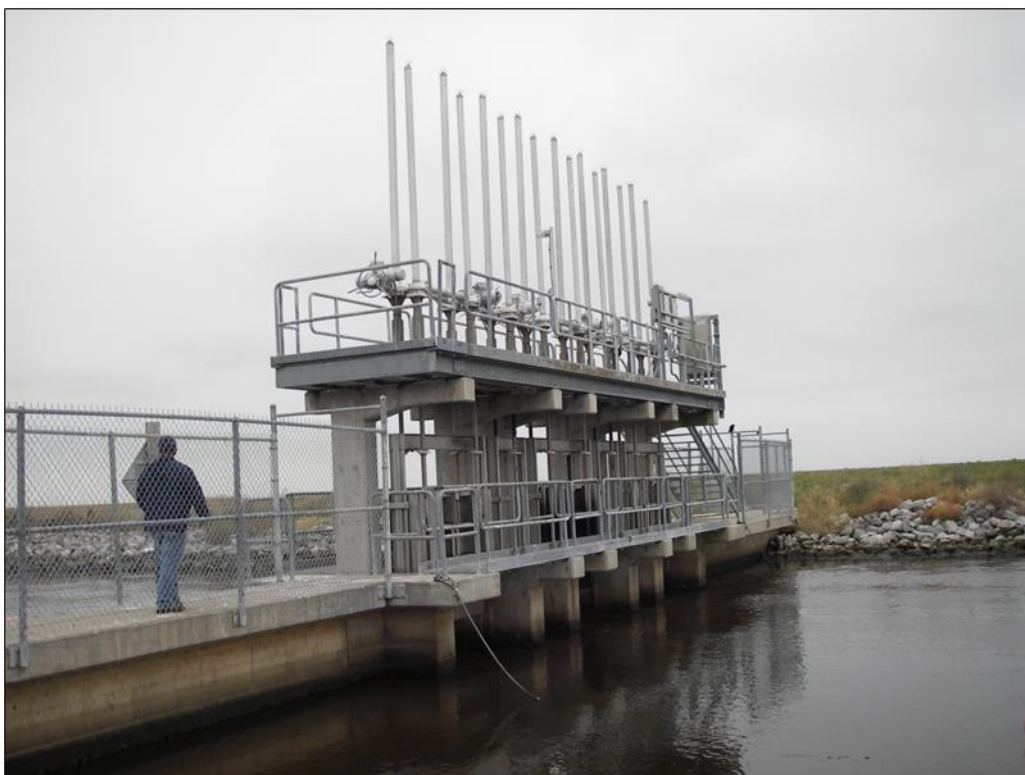
Photo No. 6, West Cove Canal from Hwy 27 side – gates being exercised and in open position
